1976 Whitby 42' Ketch

REPORT OF MARINE SURVEY

"Mac Alister"

May 22, 2004

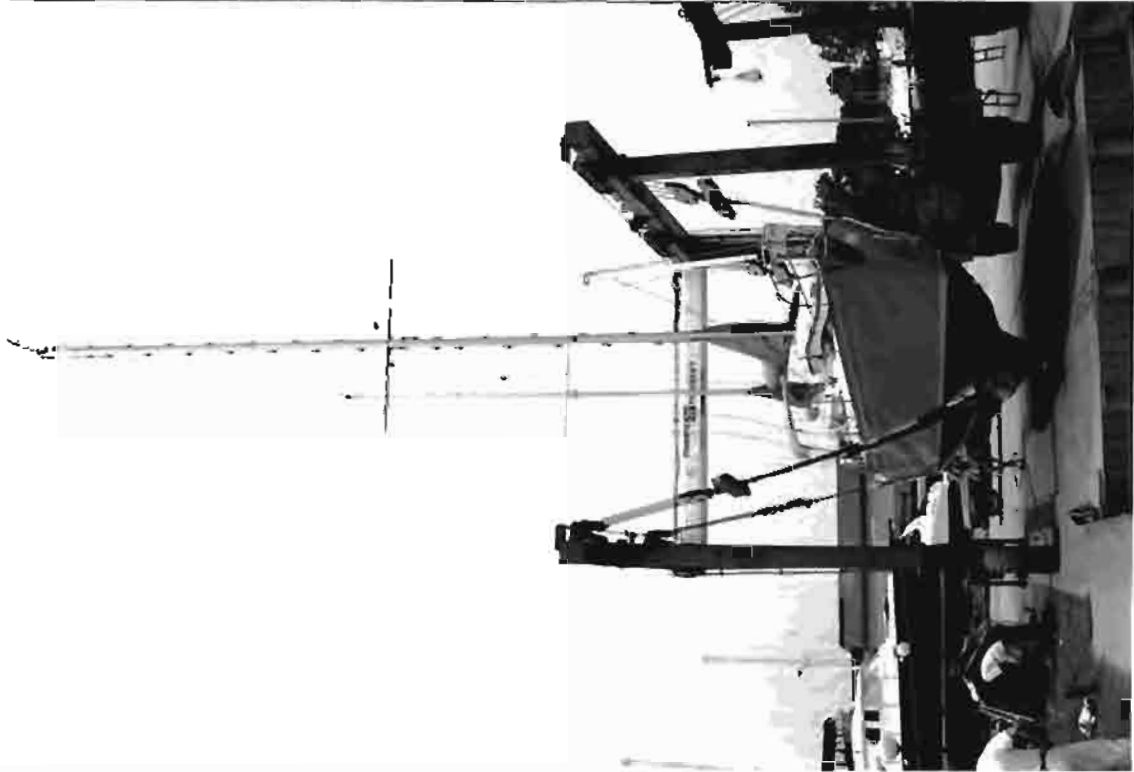
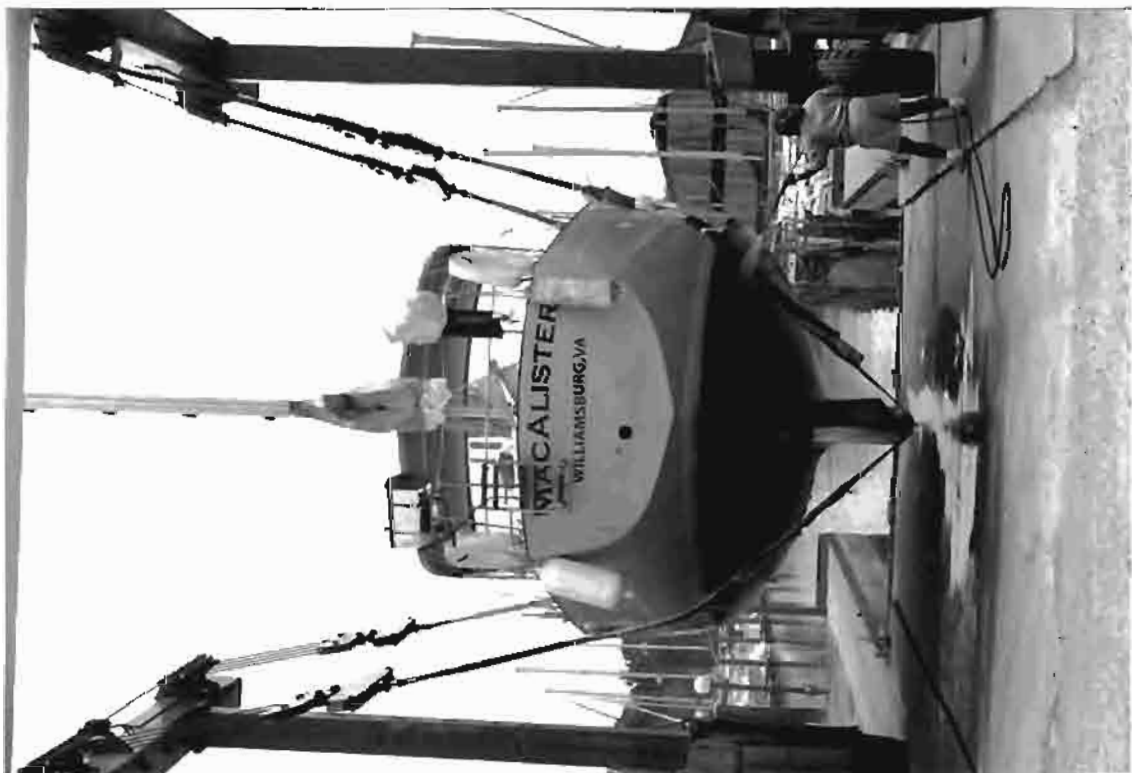
Fore and Aft Views of the Vessel on the Straddle Lift
