# GUATEMALA YACHT BROKER

Restoration of Ted Hood S/V Robin by Shipwright Frank Jolly

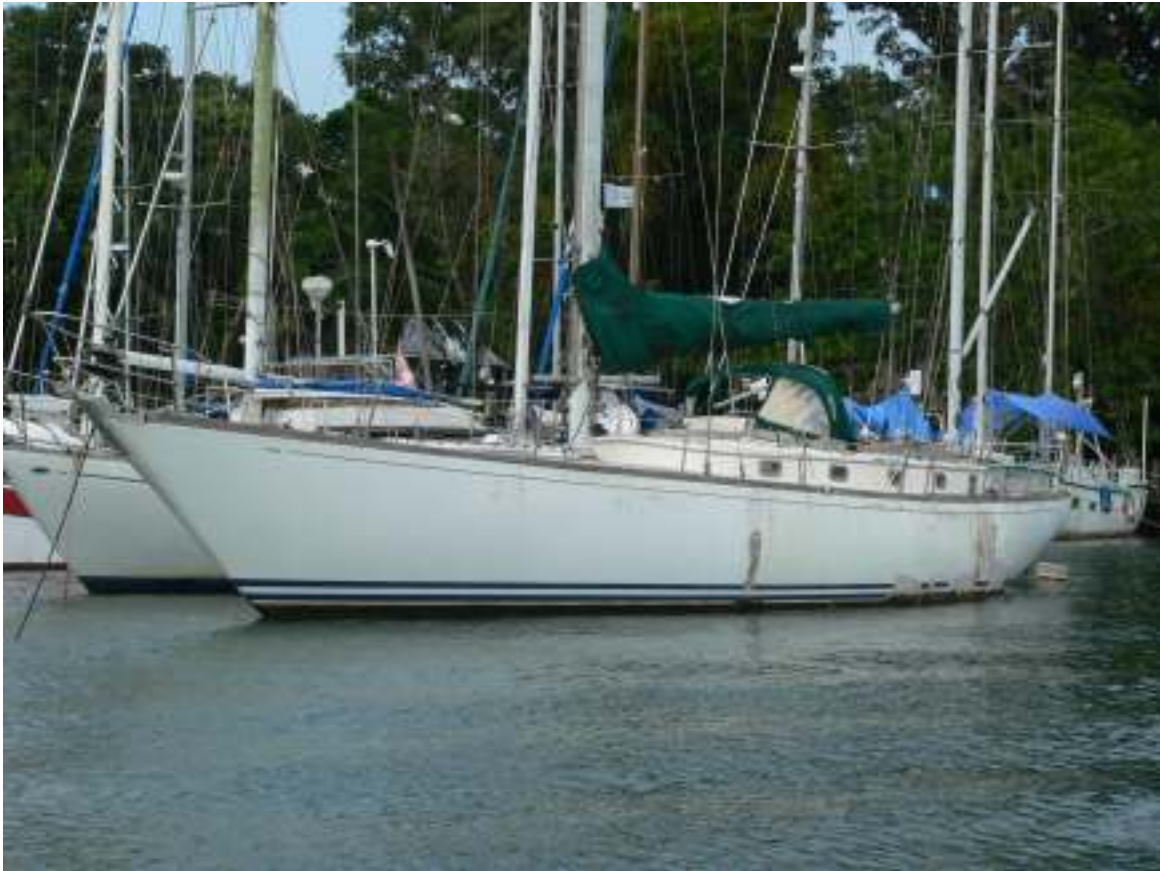
This floor plan of S/V Robin is not exact and only to give a good idea of the layout.

The boat is 53' long and 14' wide. She sleeps 8 persons in 4 cabins, 2 heads, without using the salon.

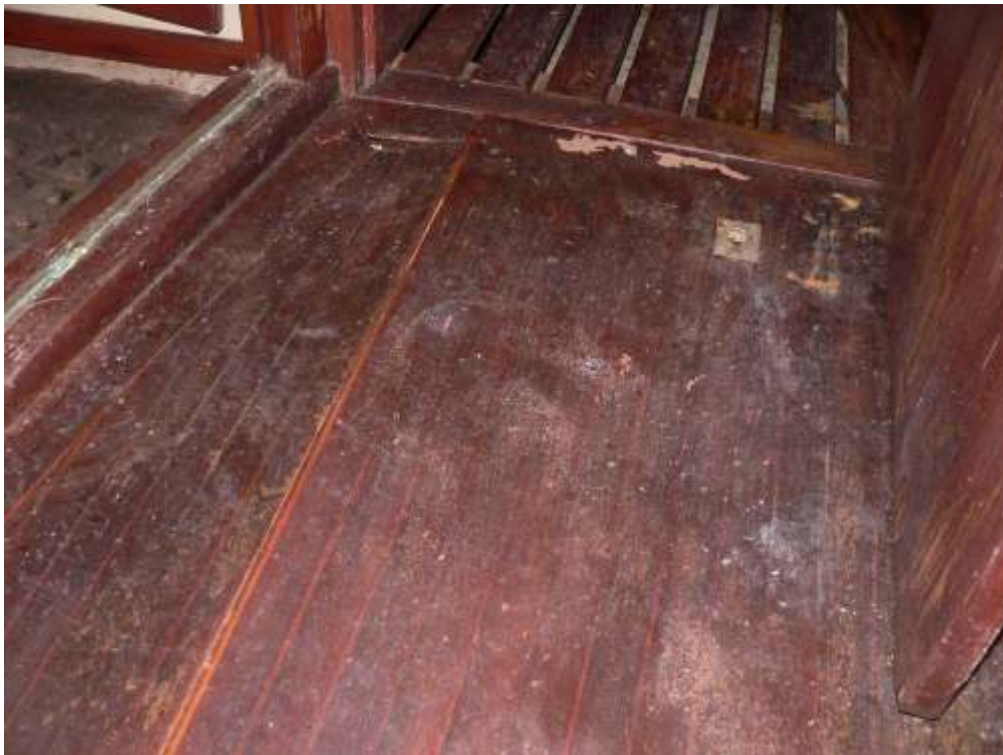
...Details of the floor in that area, you can see that is caving in, in places...

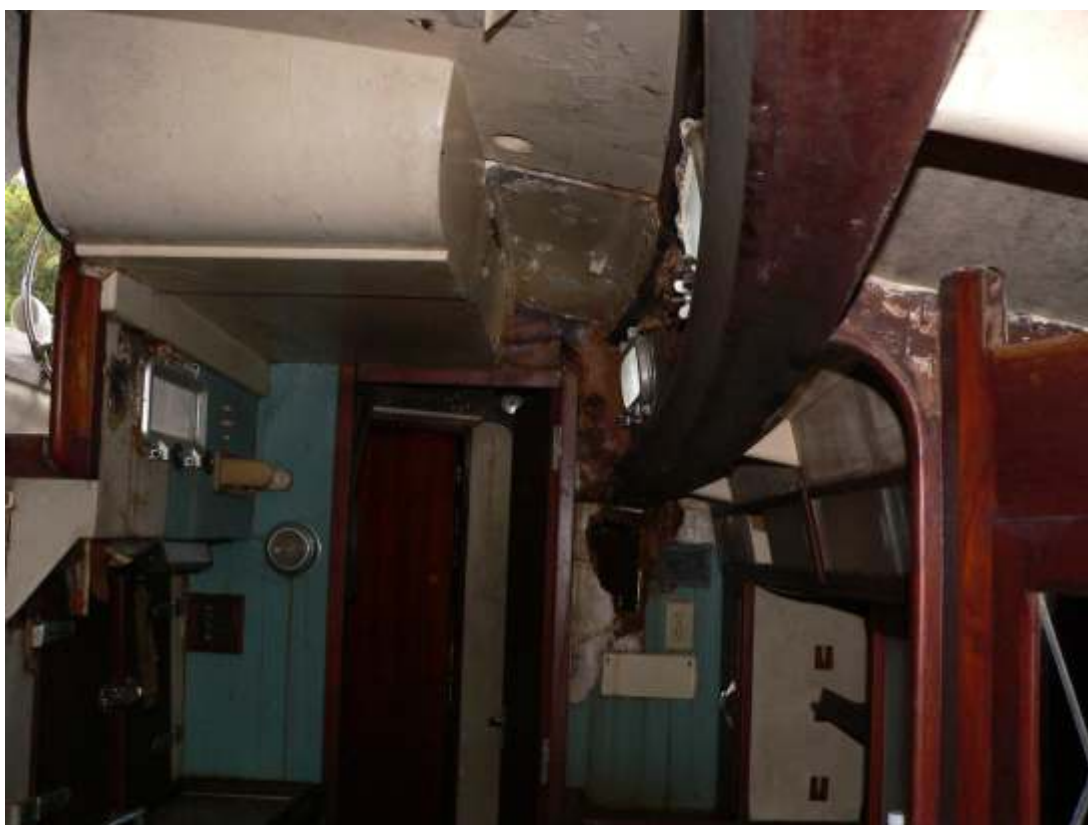
We move to the galley area and can now see the place where we were standing before with the door to the forward cabin in the middle, the navigation to the right and the back of the salon sofa seat, dead center of the boat, because it also hide the keel mechanism below the seat. Note the bad bulkhead.

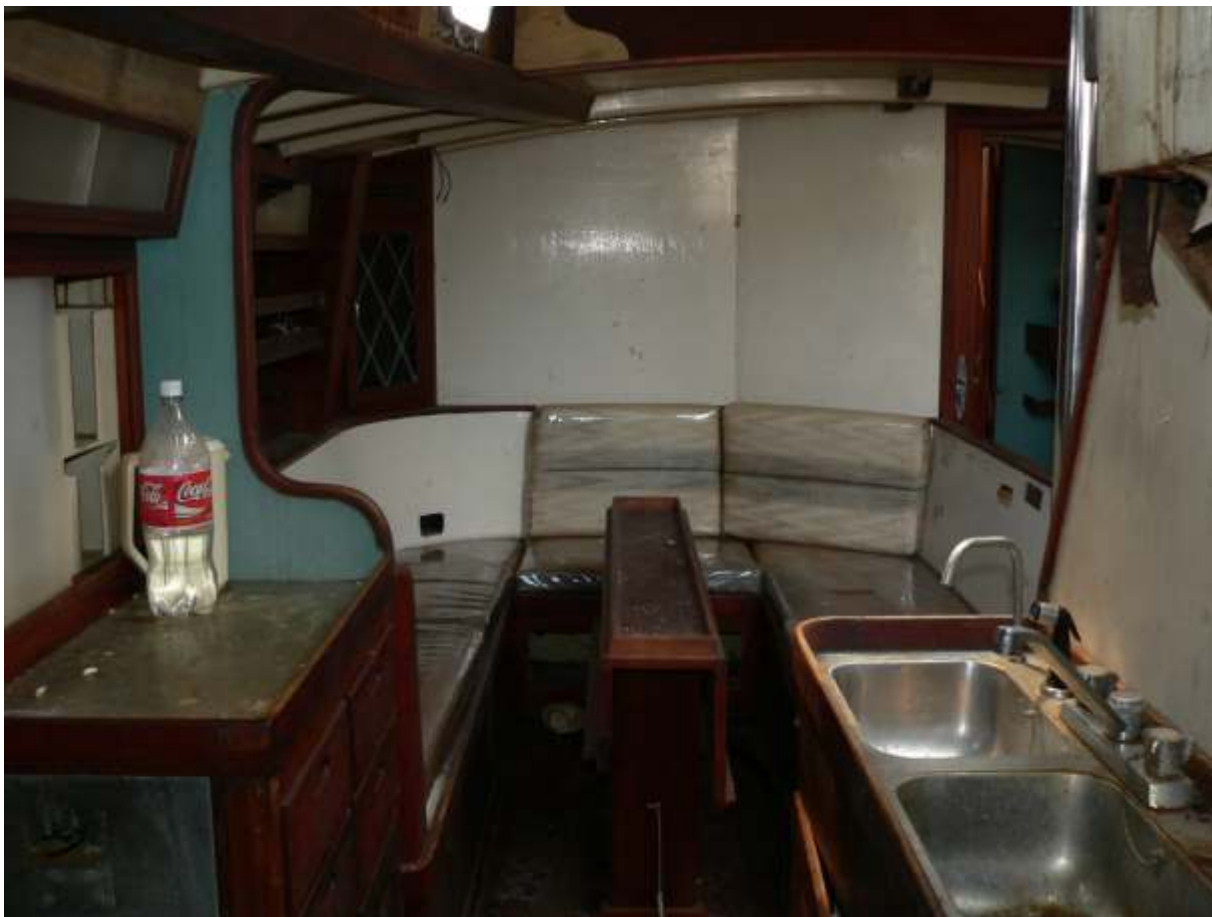
The coachroof of the galley area is damage by water, note the fridge /freezer doors on the left, the door in the middle lead to the aft head.

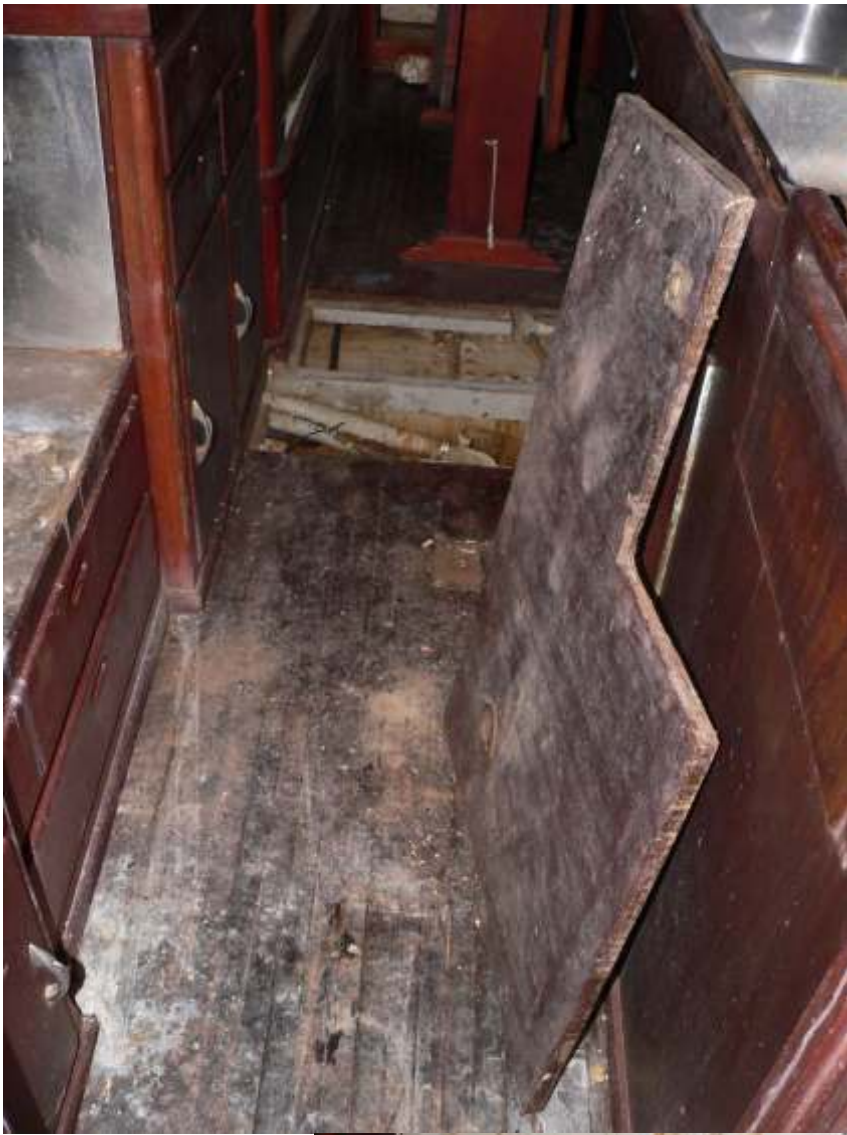
Rotten wood on the coachroof side of salon

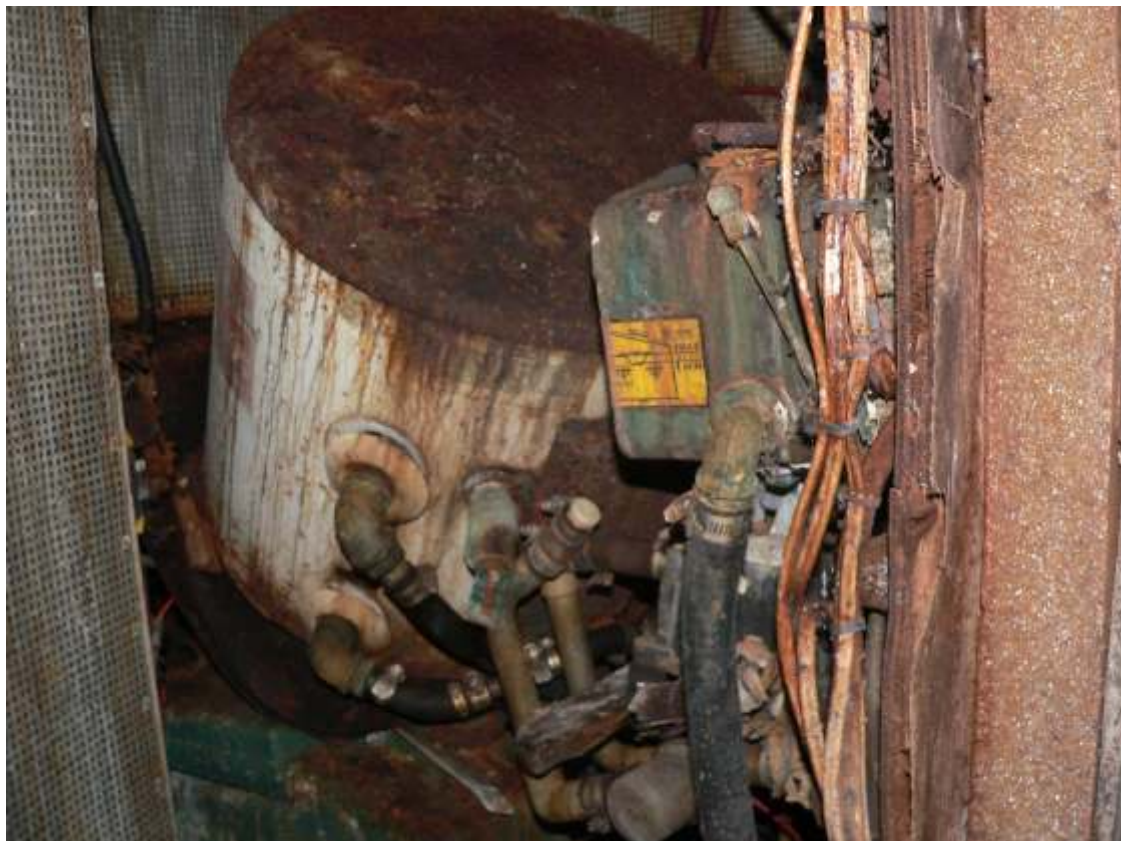
We now left the galley, come back to the main salon and look trough the doorway of the corridor like port bunks cabin (B5), on the right wall there is an access to the engine room and hot water tank that is totally rotten.

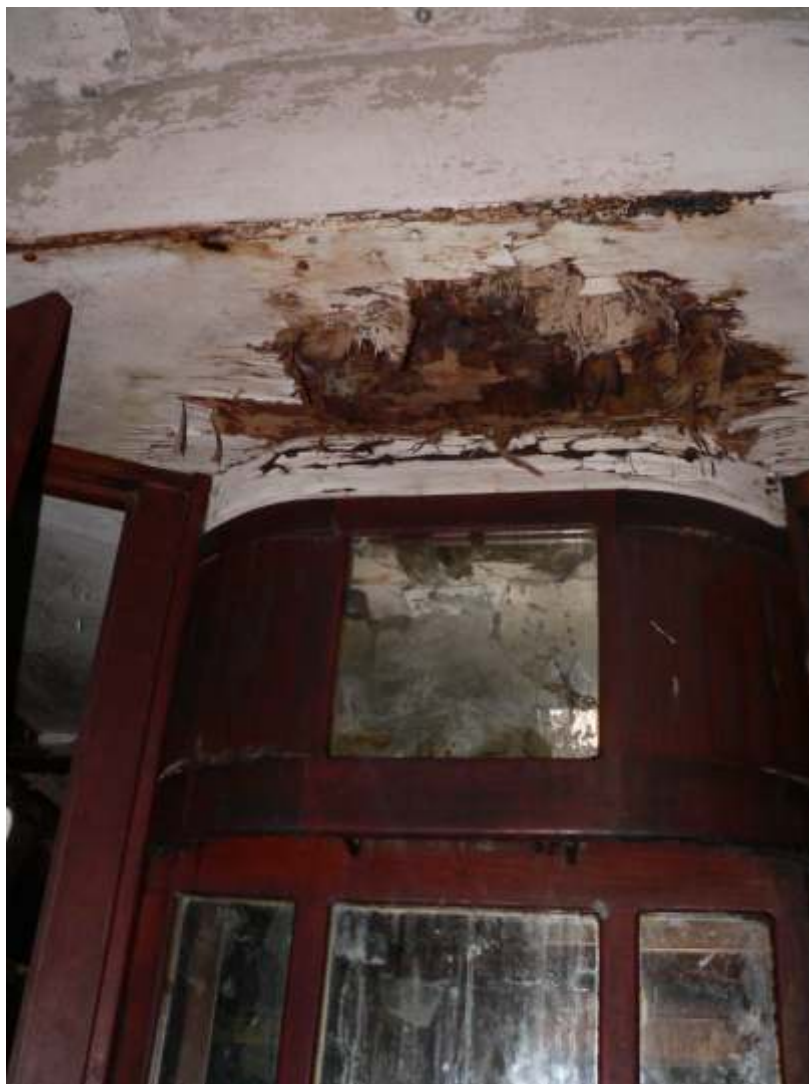
From the starboard bunk cabin we enter the aft cabin (B6), damage is bad on the bulkhead area.

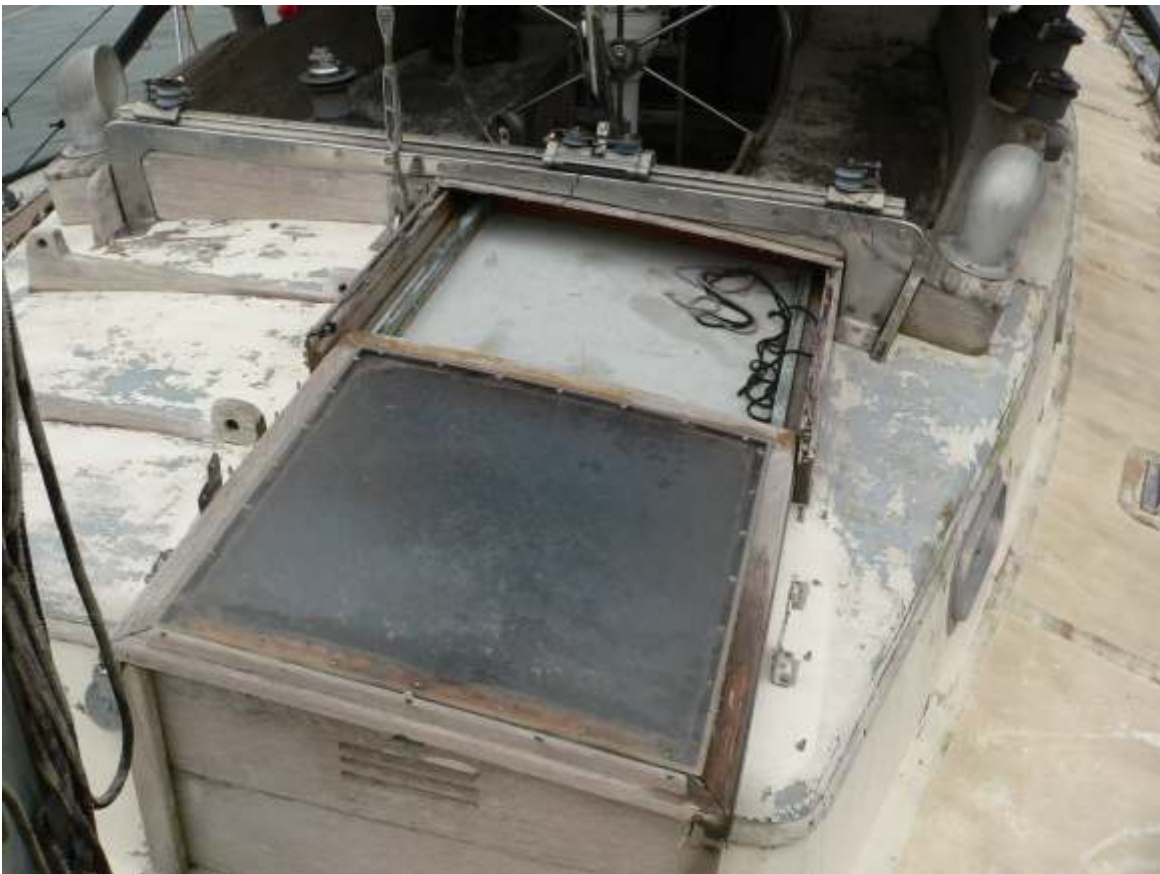
From the same vantage point as before, we have now closed the aft companion way, you can see damage to the top protection that has rotted away.  
Behind us is the aft deck that house a big empty compartment that used to house the generator and much more.

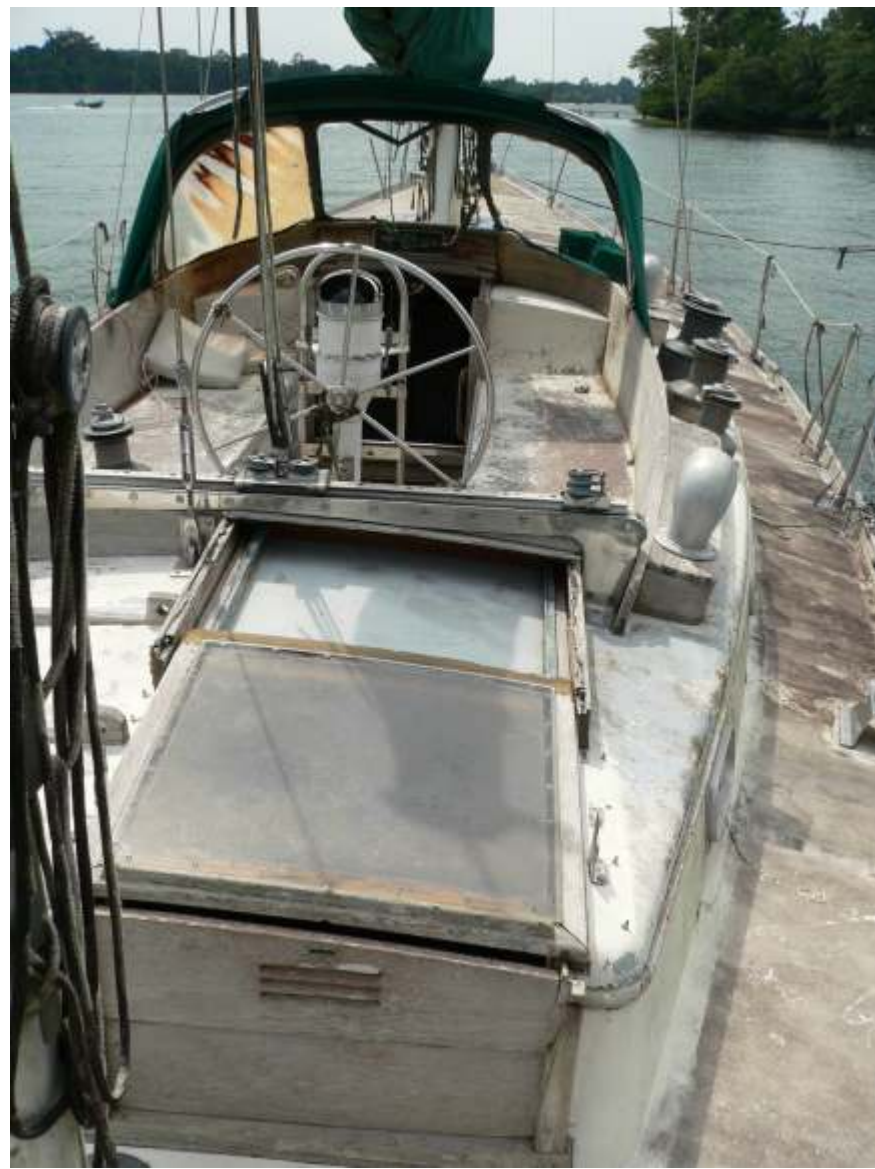
Looking up from the same place we have a clear view of the central cockpit and 6 big winches forward of the wheel for the sail tuning.

The floor is entirely destroyed there and will be cut away and replaced.

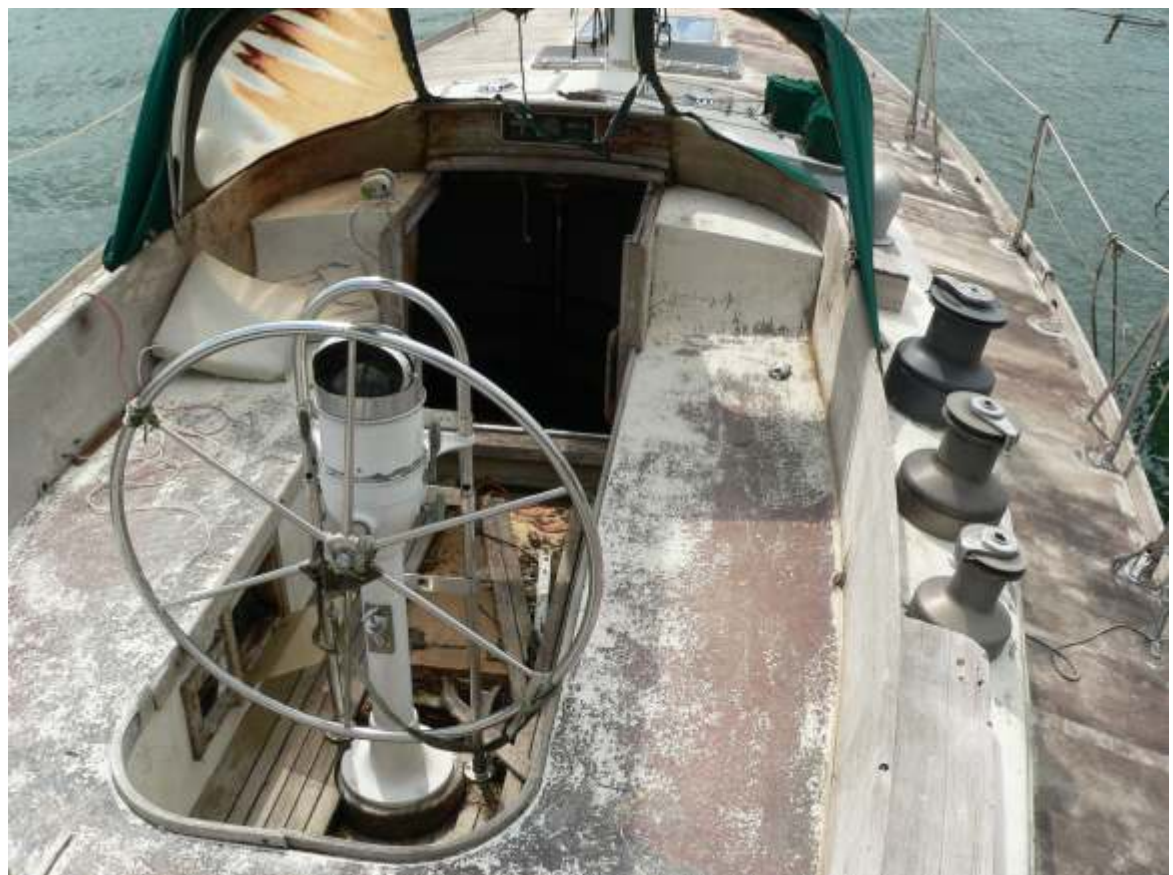
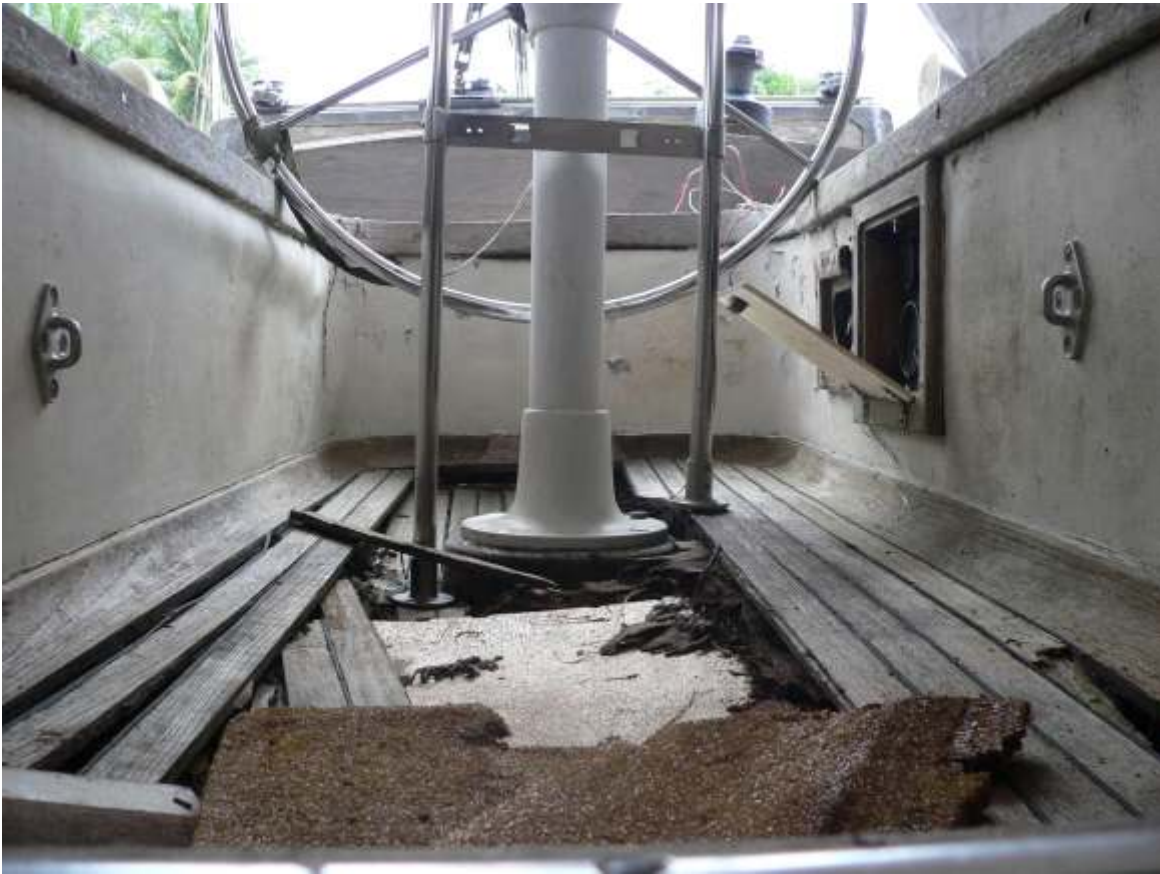
Details of damage to cockpit floor and side.

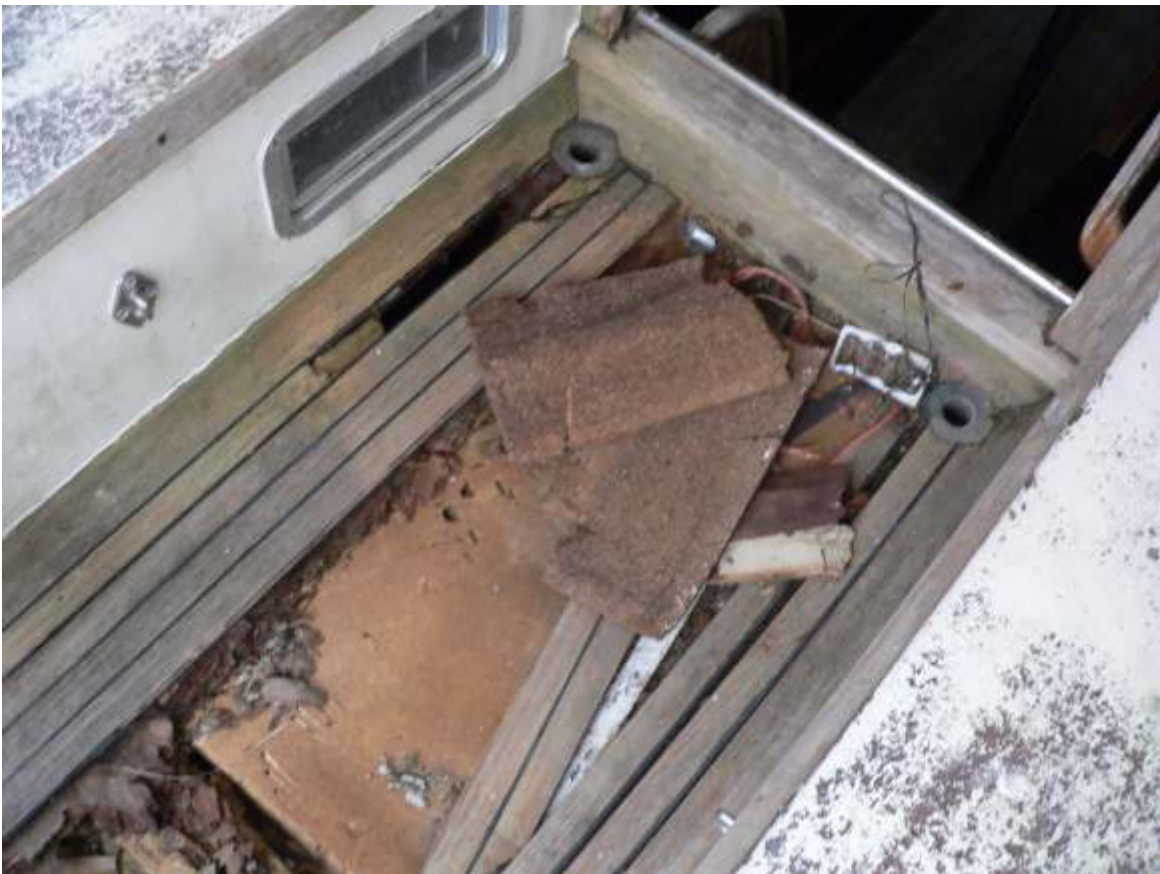
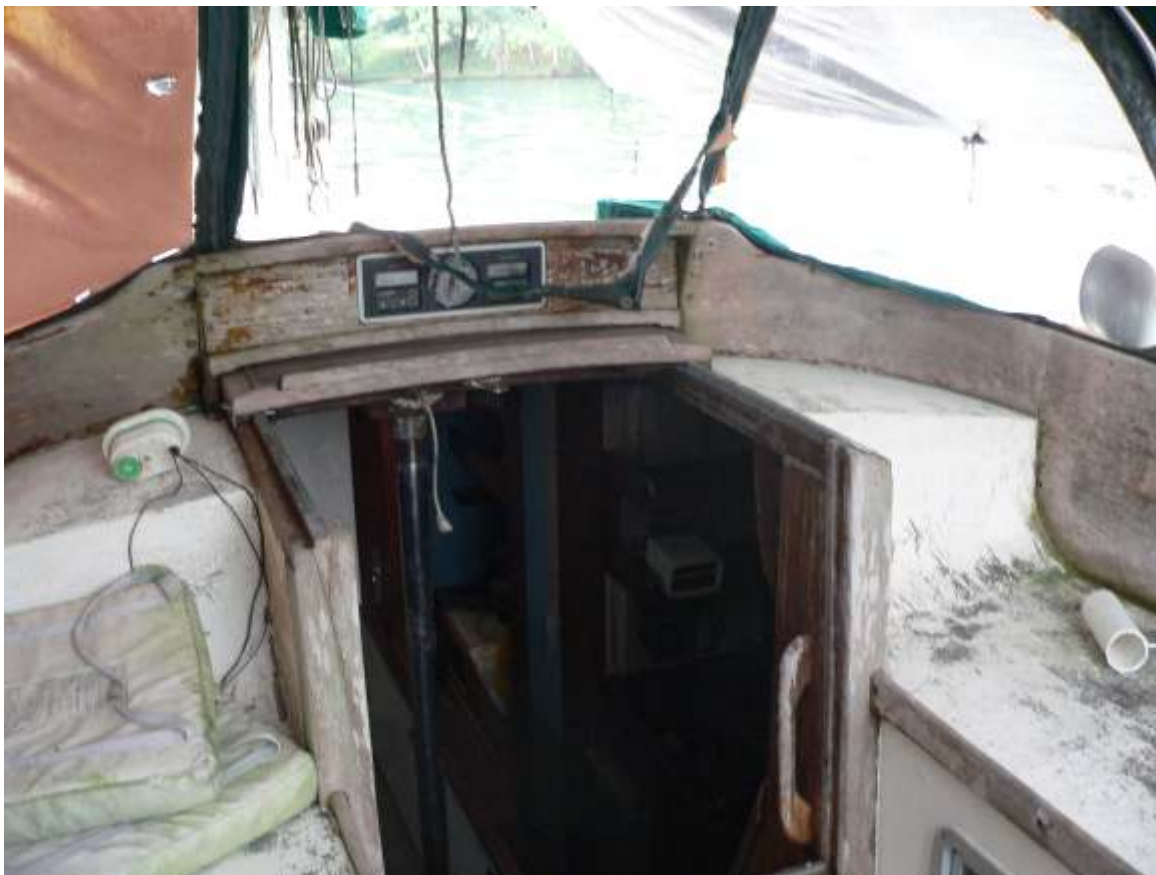
Main companion way with rotten protection. Canvas also need to be renew.

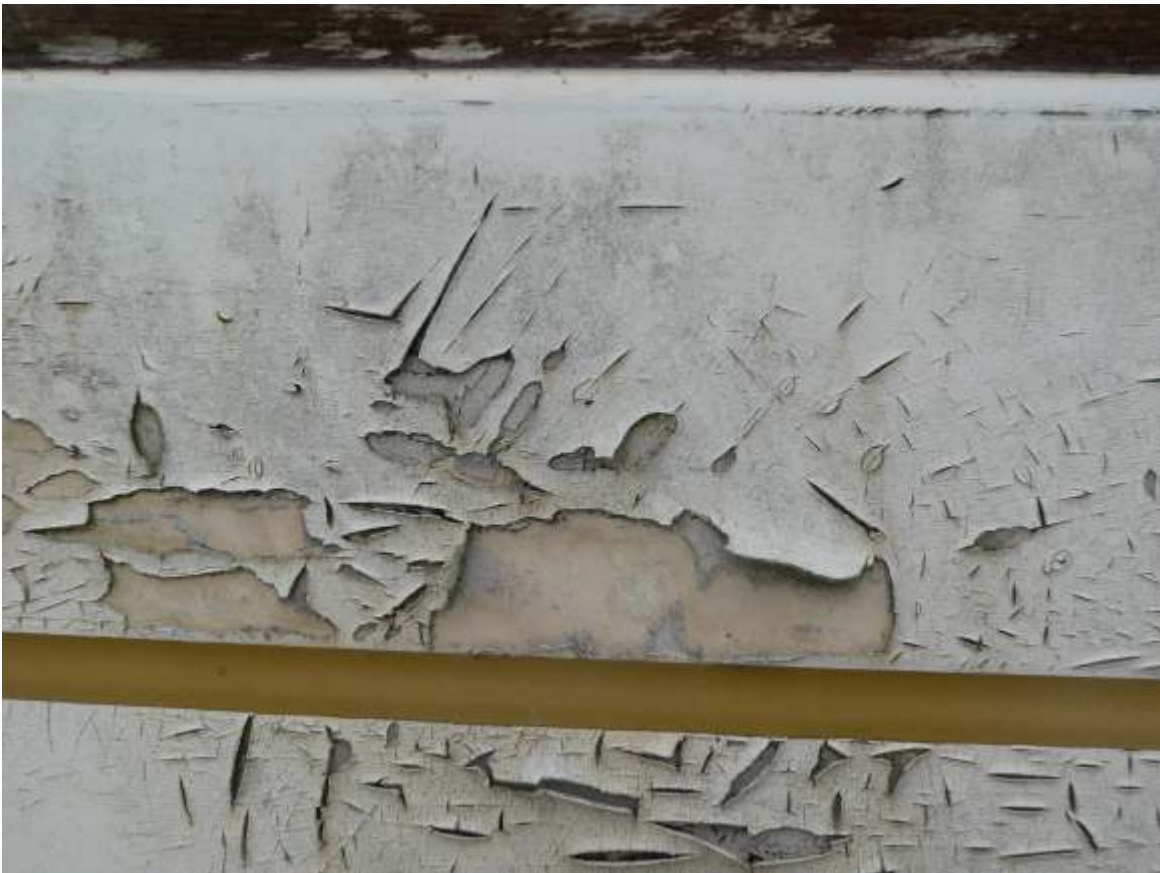
Details of paint damage to the hull side.  
Paint will have to be sand away down to fiberglass and redone from scratch,  
note that the fiberglass itself is not damage.

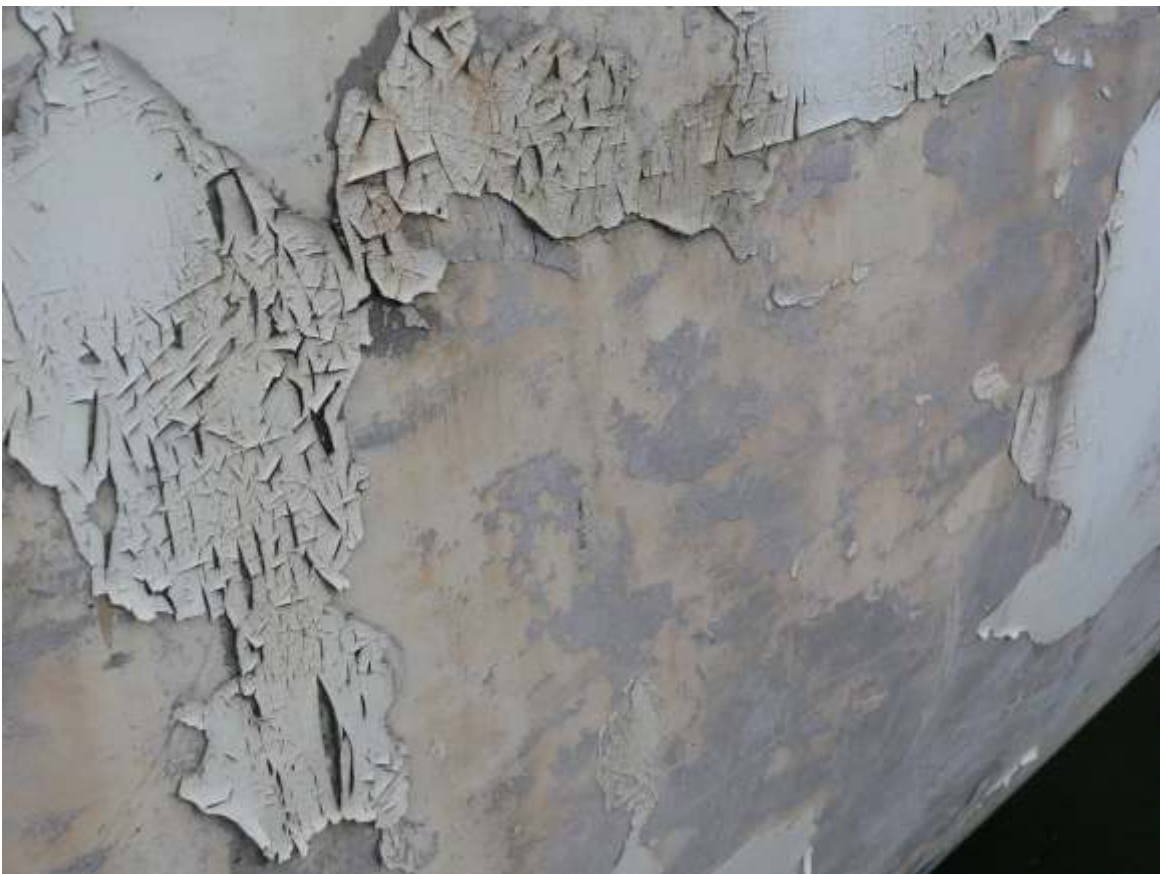
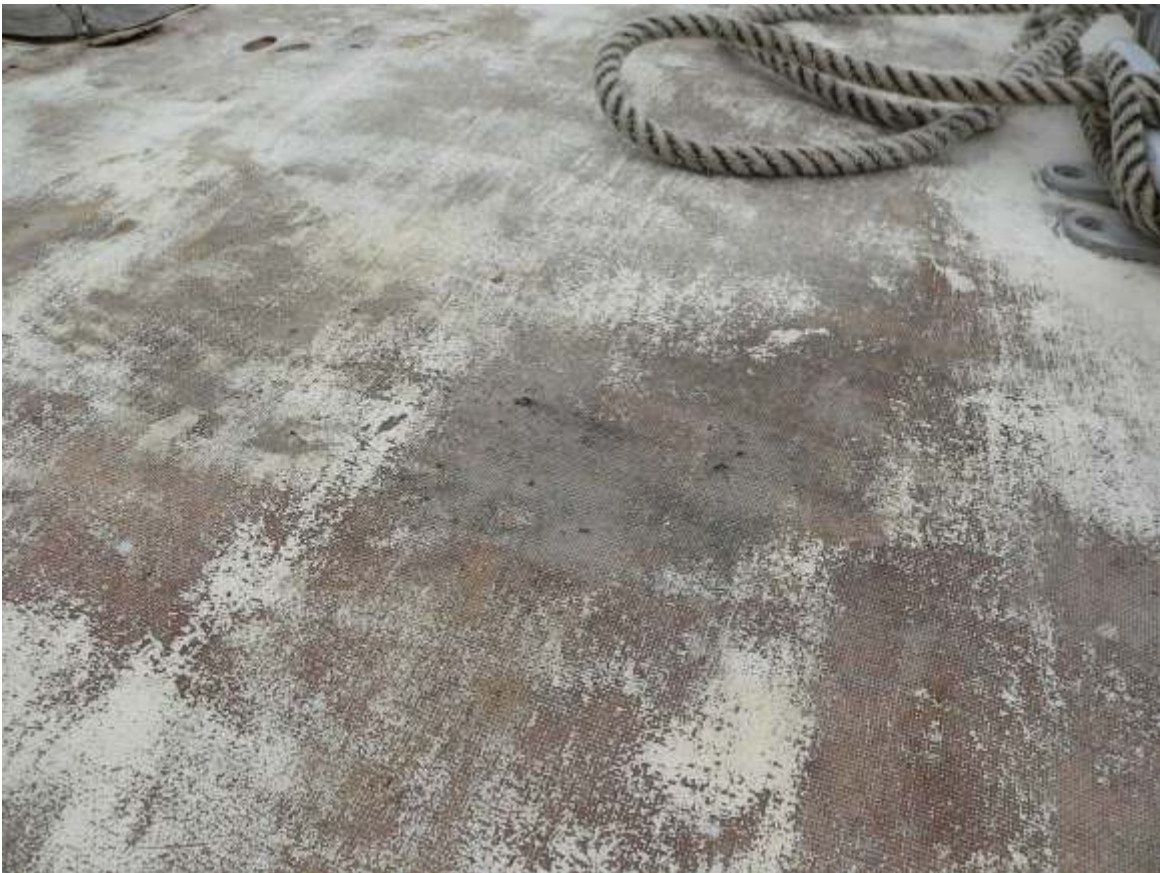
Deck was made with ply and dyneel material with epoxy resin.  
Some has been renew fews years ago and is still good the rest has to be entirely renew.!

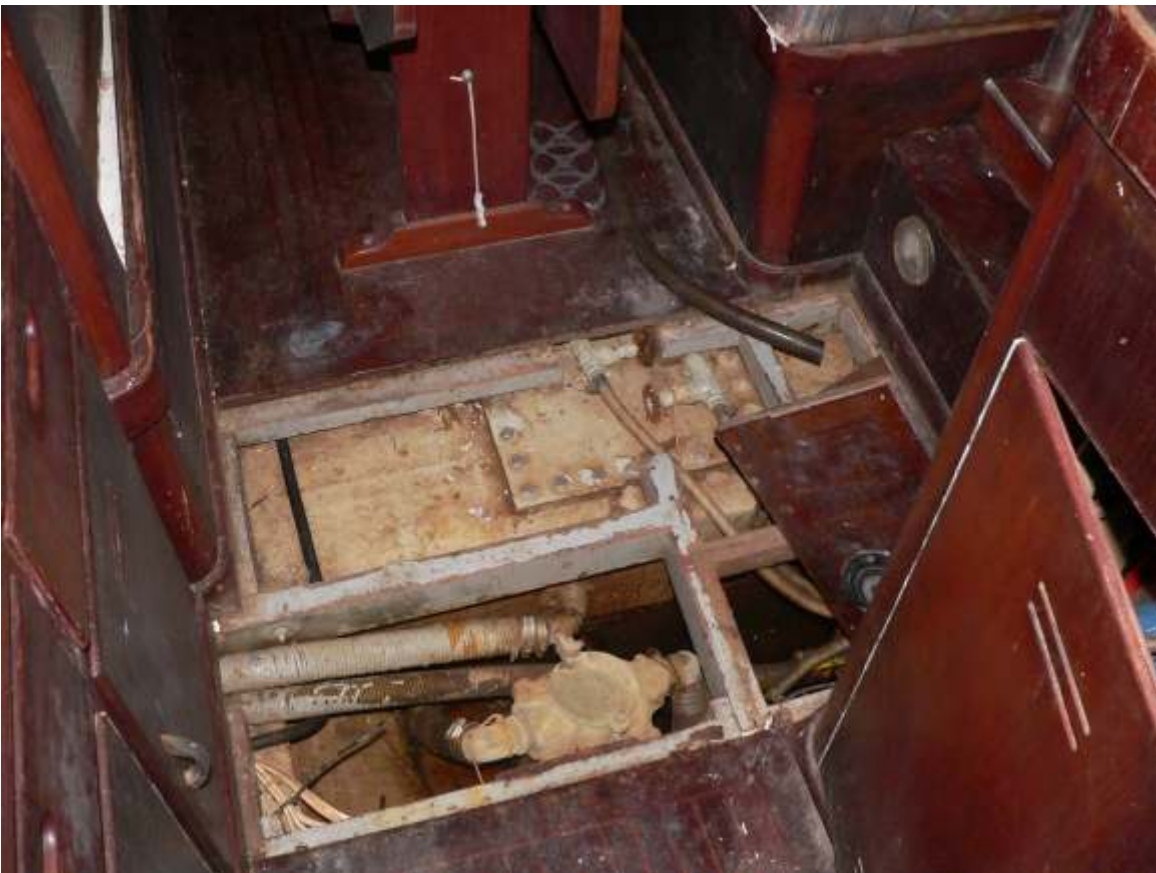
Engine view from aft cabin and some bilge and tanks between galley and salon. We think that the engine is ceased and the best is to changed it, but it maybe serviceable.
